## *Greeneville, TN Federal Savings Bank Installation and Operation Report June 28, 2016 - March 28, 2017*

Description/ pictures of the operation/ including sump/basin/fill and airside of fill

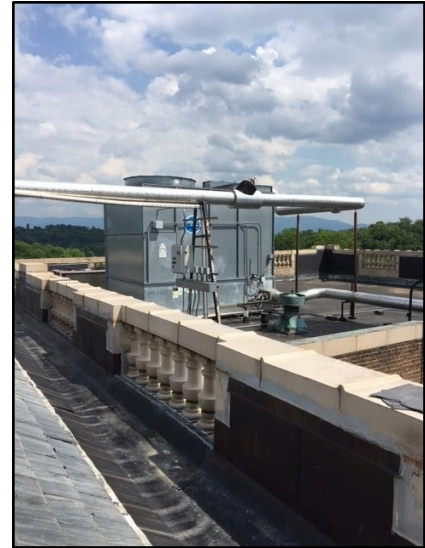
*Position of Cooling Tower on roof*

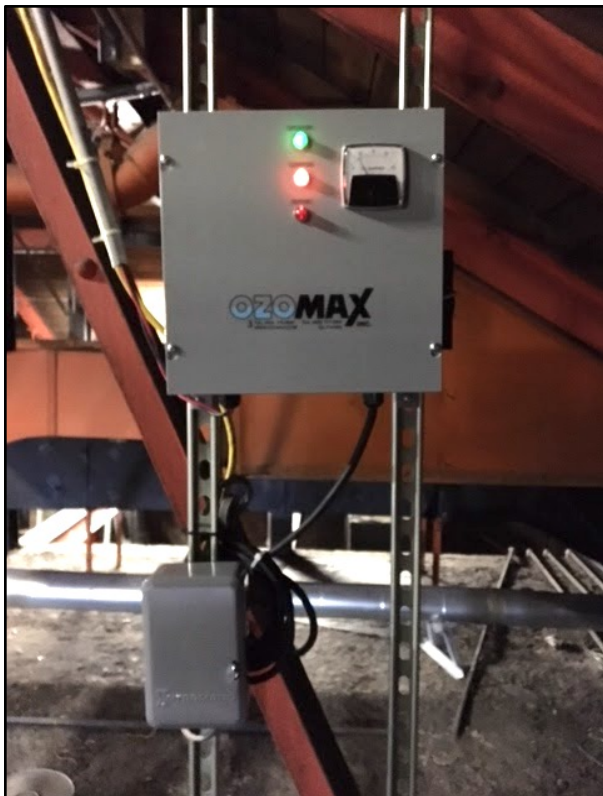
*Ozomax Headworks installed in building attic*

Installation consisted of an "Ozopen"<sup>TM</sup> control panel/head works (Plug/Play) in the attic of the building, plugged into a 20 amp/ 120vac receptacle. Low Voltage (24vdc) wires were routed through PVC conduit to a probe device (Ozopen) in the sump of the cooling tower. Installation took less than one day. A small recirculating pump and a 5-micron filter were added to remove sediments and particulates precipitated by oxidation of organics/ dust treated in sump.

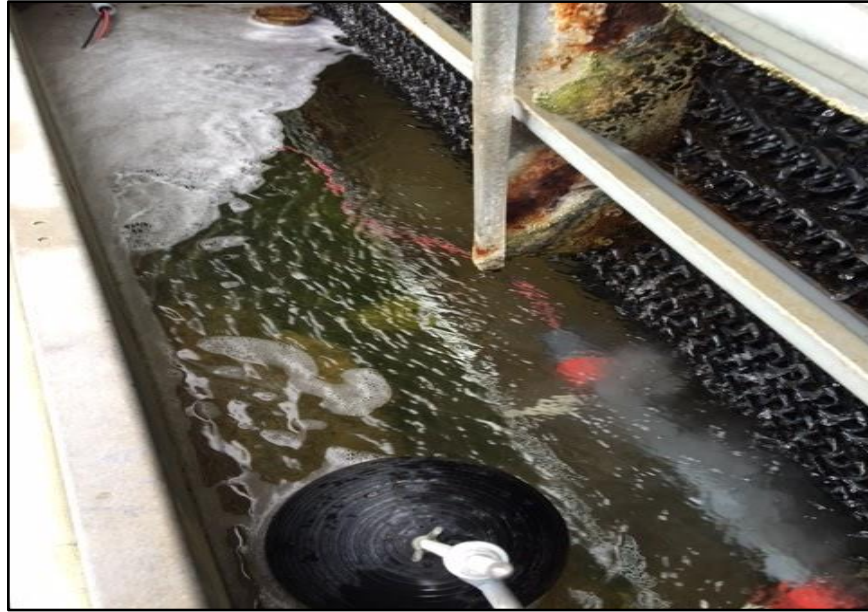
*OzoPen placed in Cooling Tower sump. Note bubble diffusion in water*

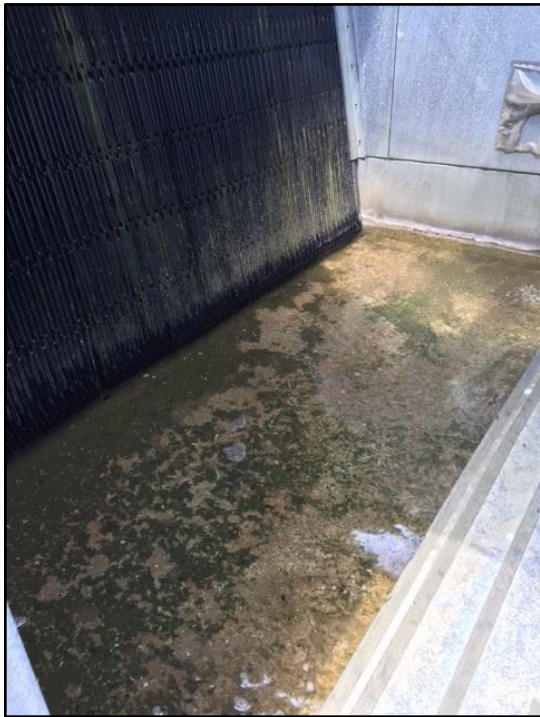
Before: Algal deposits on floor of sump- air side

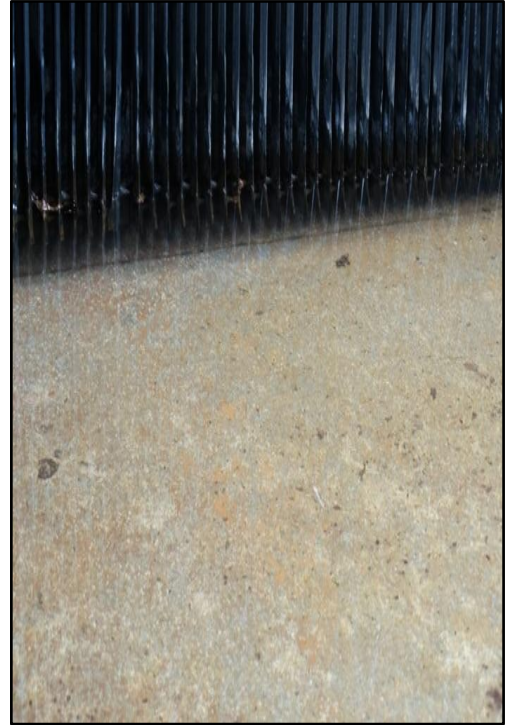
After: Floor of sump- air side

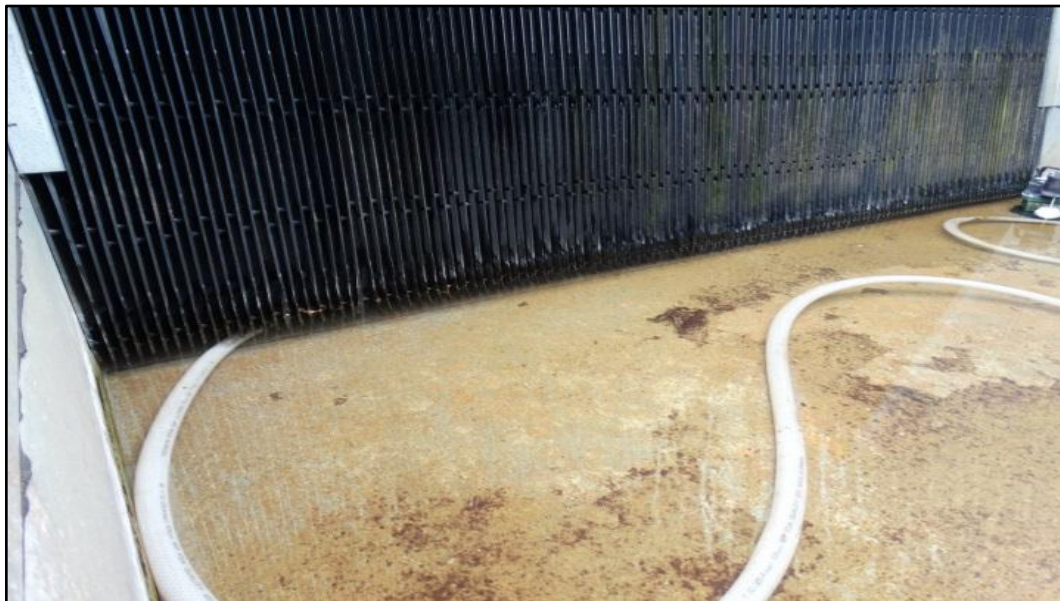
After: Note flex hose of filter pump used to remove oxidized particulates

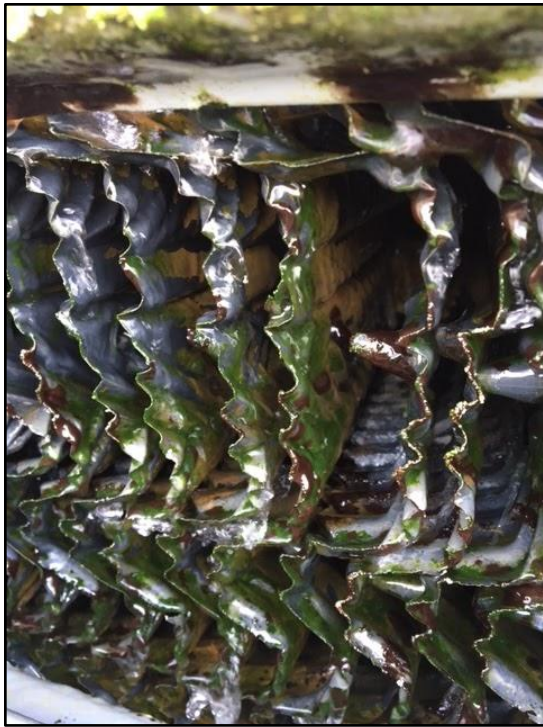
Before: Fill showing algal/ biofilm deposits/growth
